# Shore Acres Pump Station Forcemain Failure Analysis

Board of Directors Meeting  
March 12, 2025

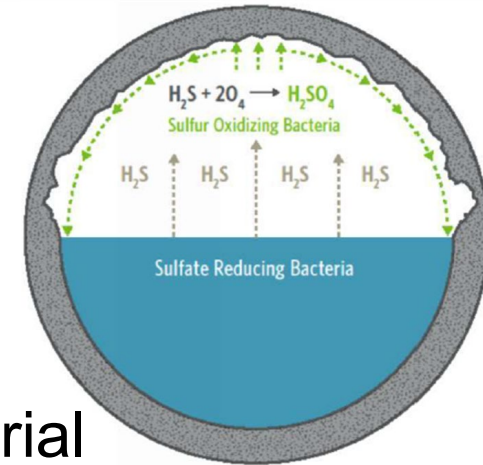
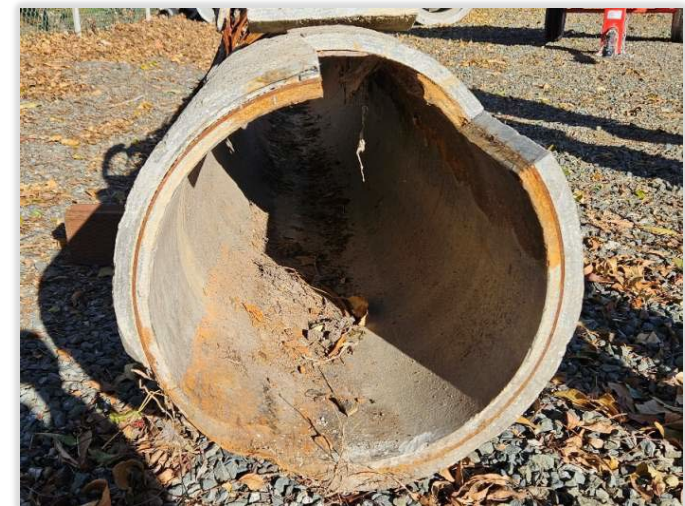
- Root Cause: Internal corrosion of concrete lining and steel cylinder from hydrogen sulfide gas [ $\text{H}_2\text{S}(\text{g})$ ] caused failure
  - HDR ruled out vandalism, equipment malfunction, over-pressurization, operational conditions
- Contributing Factor No. 1: Existing Pipe Material
  - Existing bar-wrapped concrete cylinder pipe is susceptible to corrosion in wastewater applications—more modern, corrosion-resistant materials are now available (e.g., HDPE, PVC)

- Select modern pipeline materials (e.g., HDPE, PVC are more corrosion resistant)
- Consider a smaller diameter pipeline (e.g., 14-inch instead of 16-inch diameter) to increase flow velocity and construct new pipeline with appropriate slope
- Provide pipe inspection and maintenance access features
- Evaluate chemical addition alternatives to protect against corrosion in entire wastewater conveyance system

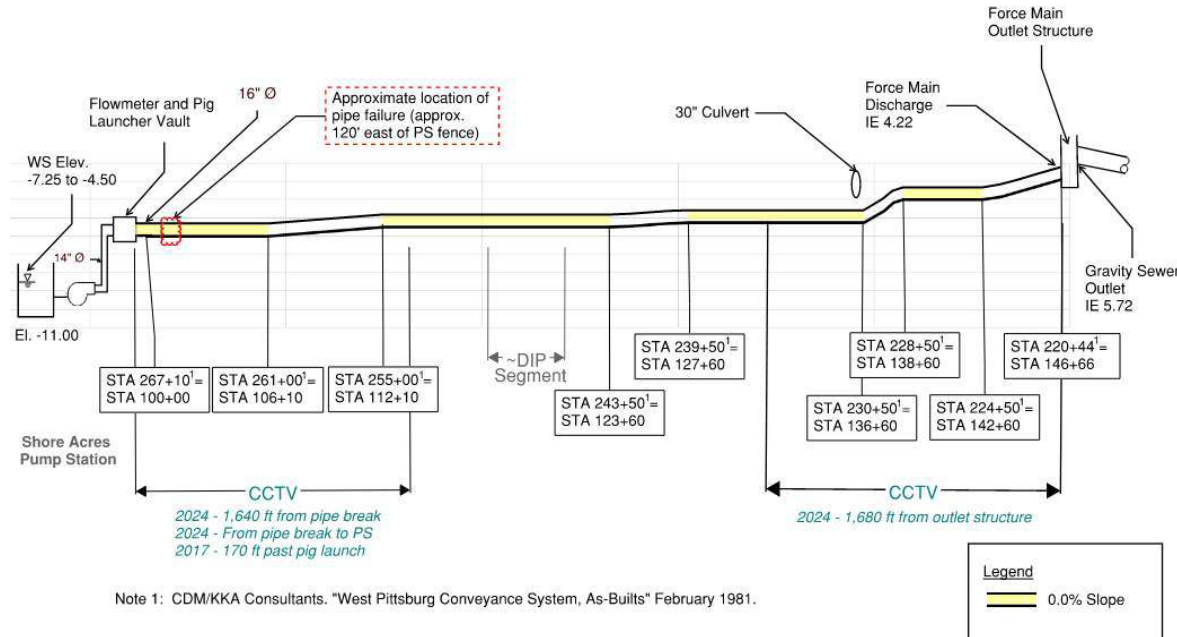
- Contributing Factor No. 2: Low Wastewater Flow Velocities**
  - Flow velocity is below recommended rate (due to wastewater flow rates, existing pipe diameter) to move air pockets and avoid suspended solids deposition (i.e., increased corrosion potential)
- Contributing Factor No. 3: Lack of Forcemain Slope**

- A vertical alignment with little-to-no slope inhibited movement of  $H_2S(g)$  pockets and precluded use of air release valves at high points

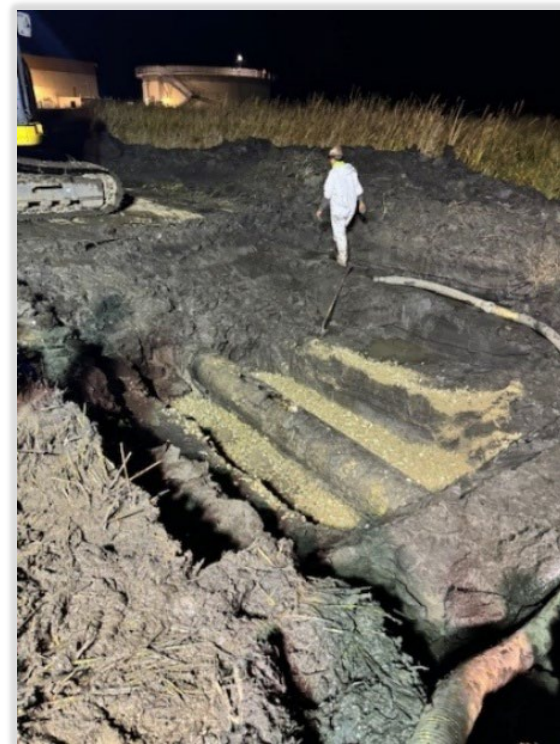
- Contributing Factor No. 4: Challenging Site Conditions
  - Geotechnical investigations identified presence of Bay Mud with potential for 0.5-1.5 feet of settlement if pipe was constructed on uncompacted backfill
  - Original as-built construction records indicate pipe was constructed on compacted bedding and backfill
  - However, constructing a pipe with no slope in these soil conditions is challenging; local high points that trap  $H_2S(g)$  may be present due to construction irregularities or localized settlement in multiple locations

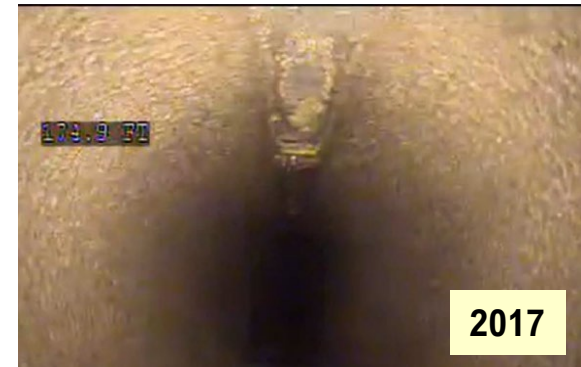
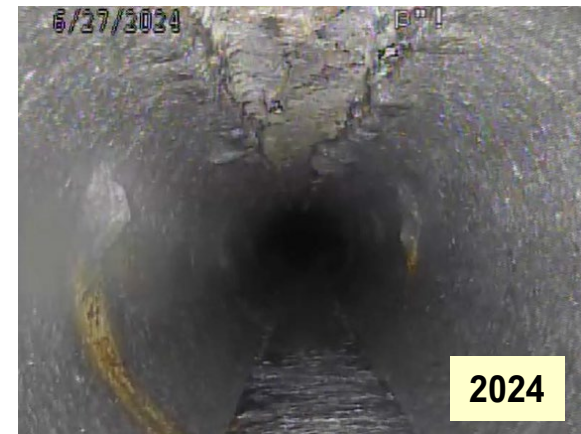
- 3,200 feet of CCTV footage recorded during emergency repairs
  - Five locations with severe corrosion, minor corrosion over half of length
- 240 feet of CCTV footage (2017) identified minor-to-moderate cement lining defects—formal review not conducted in 2017
- “Facility Condition Assessment Project Report” (July 2020)
  - Engineering consultant estimated 15 to 30 years of remaining service life based on “desktop analysis” (age, material, service conditions)
