# NPDES Permit Compliance: Chlorine Residual Limit Exceedance

Board of Directors Meeting  
October 14, 2020

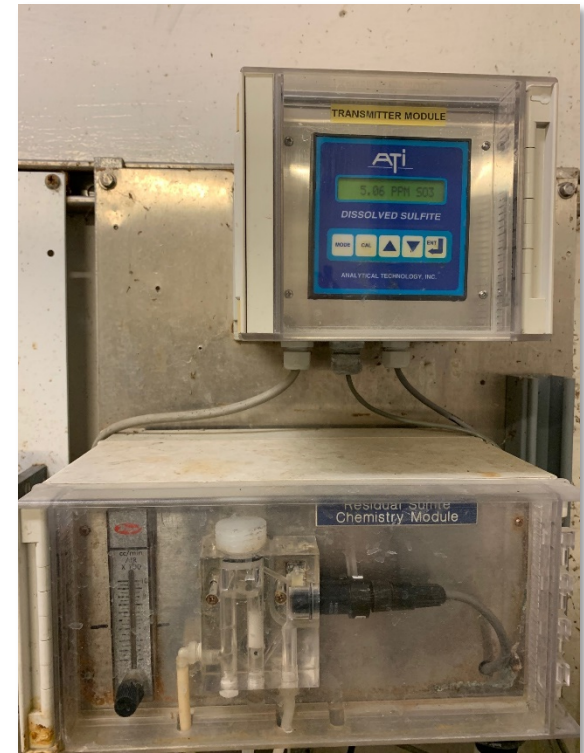
- Following treated effluent disinfection with chlorine, sodium bisulfite (SBS) is used for “dechlorination” to ensure residual chlorine is removed prior to discharge
- Two automated SBS analyzers (duty, standby) are used to control SBS feed pumps and continuously monitor and maintain excess SBS residual
- These critical SBS analyzers are checked daily and frequently calibrated in accordance with established District standard operating procedures (SOPs)
