# Shore Acres Pump Station Forcemain Failure Analysis

Board of Directors Meeting  
March 12, 2025

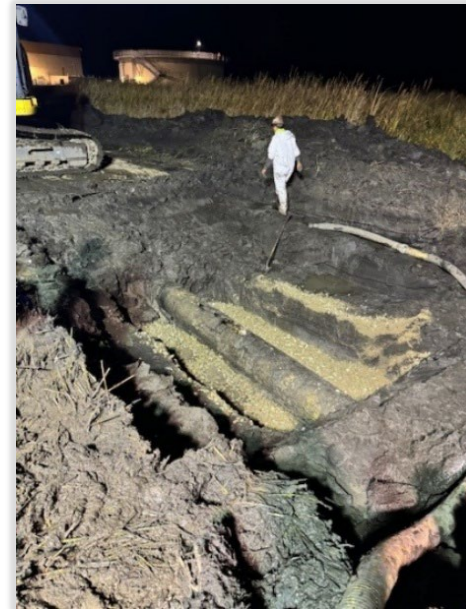
- Following identification of break (Dec 2024), District hired HDR to conduct technical forcemain failure analysis
  - Meets regulatory reporting requirements
  - Results submitted as part of 90-day Amended Spill Technical Report (submitted, March 4, 2025)
- HDR reviewed SAPS operating info, maintenance records, failed pipe materials, and prior studies/reports
  - Goal: Identify failure **root causes** and **contributing factors**
- Background Information
  - Installed in 1980, 4,700 feet in length, 16-inch diameter bar-wrapped concrete cylinder pipe with a 200-foot ductile iron pipe section
  - Little-to-no pipe slope with liquid oxygen feed system for odor control
